Photographic Log for Memphis Regional Intermodal Facility

Operator:		Site Location:	Tracking No.:
Norfolk Southern Railway Company		Rossville, Fayette County	TN0081108
Photo No.	Date		
1	8-30-12		
Description <ul style="list-style-type: none"> • Phase 1A EC-11 • The swale located south of the eastern wye track and main line track up-gradient from SW23 is shown in this photo. • The bottom of the swale appeared to be sufficiently stabilized/vegetated. However, the slopes of the berm were not - see photo 2 for close-up of berm. • Although the berm appears to have more established vegetation than during the March 12, 2012, inspection, the berm remains insufficiently stabilized/vegetated.

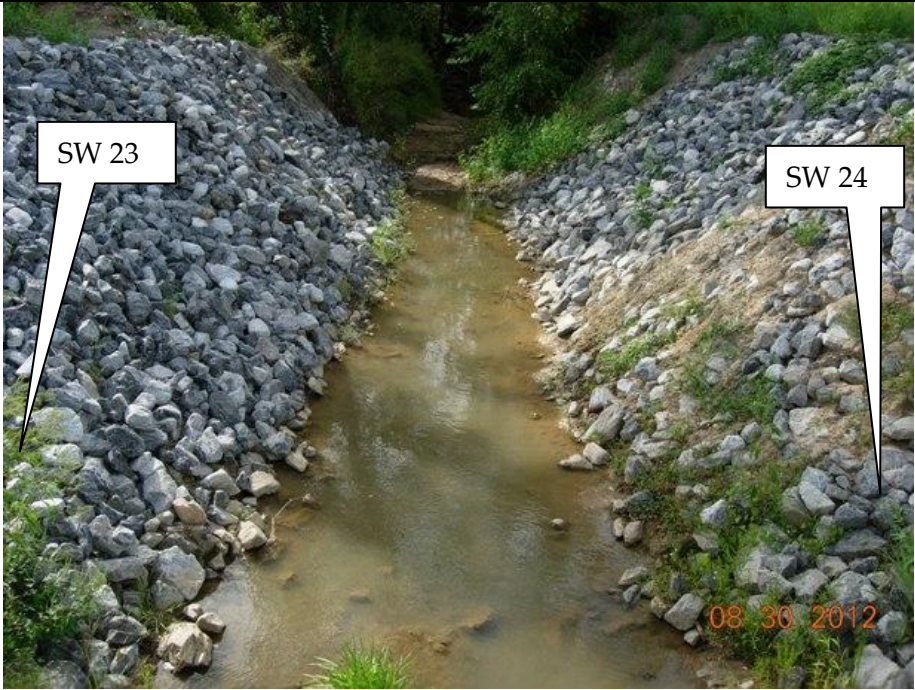
7	8-30-12		
Description <ul style="list-style-type: none"> • Phase 2 EC-21 • Stream 5 looking upstream from the eastern wye bridge over Stream 5. • The banks of the stream appeared to be sufficiently covered with rip rap.

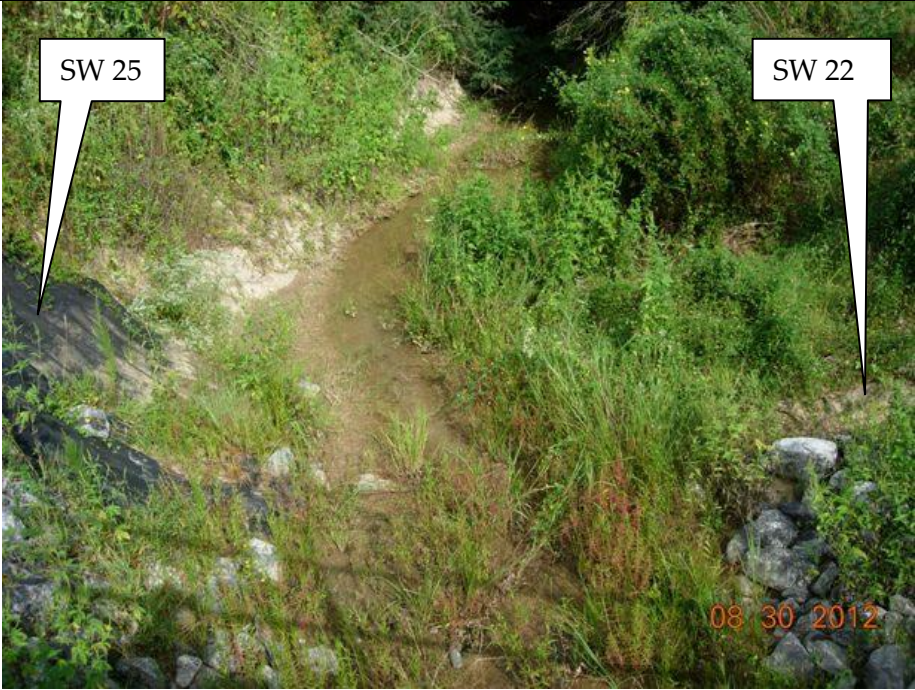
8	8-30-12		
Description <ul style="list-style-type: none"> • Phase 2 EC-21 • Stream 5 looking downstream from the eastern wye bridge over Stream 5. • The fabric on the bank of Stream 5 adjacent to SW25 did not appear to be permanent or provide adequate stabilization.

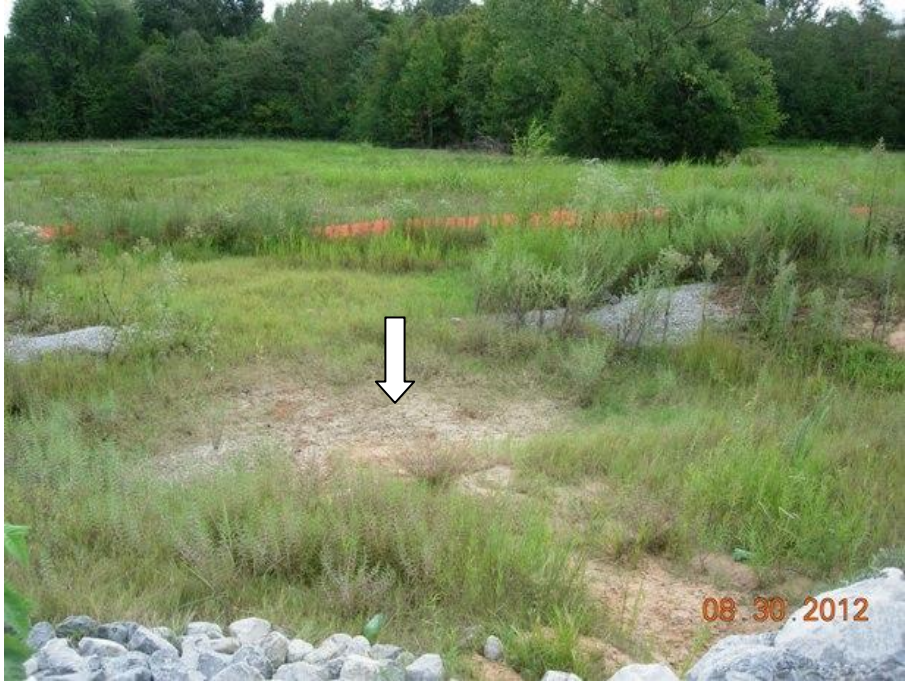
13	8-30-12		
Description <ul style="list-style-type: none"> • Phase 2 EC-23 • SW3 • The area surrounding SW3 appeared sufficiently vegetated/stabilized, except for a few areas, including but not limited to the area directly down-gradient of the headwall and rip rap (arrow).

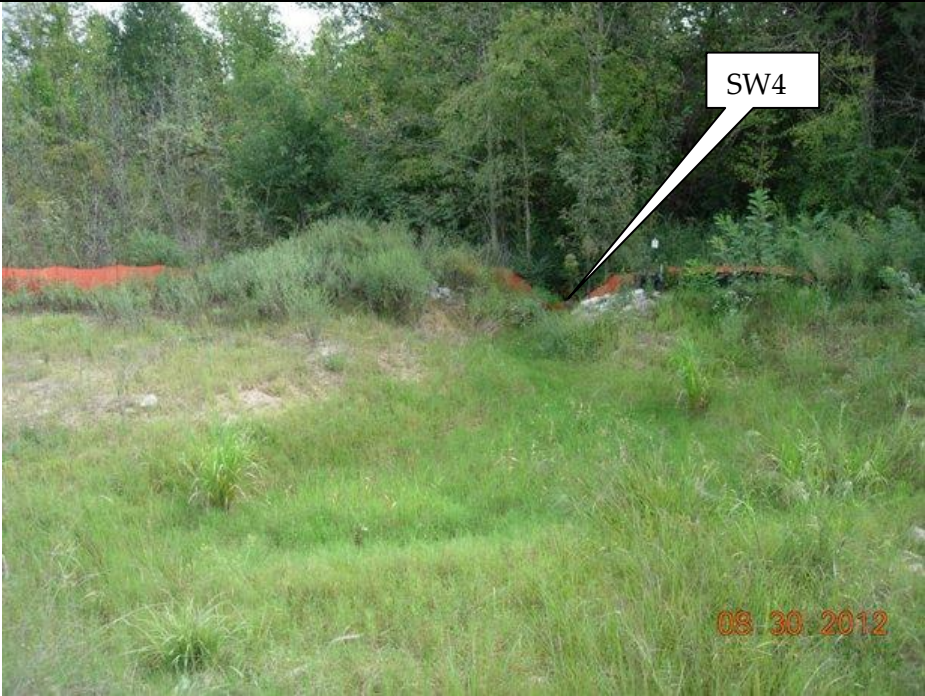
14	8-30-12		
Description <ul style="list-style-type: none"> • Phase 2 EC-23 • SW4 • The area surrounding SW4 appeared sufficiently vegetated/stabilized, except for a few areas, including but not limited to the area north of the outfall adjacent to the Enhanced Rock Check Dam (ERCD).

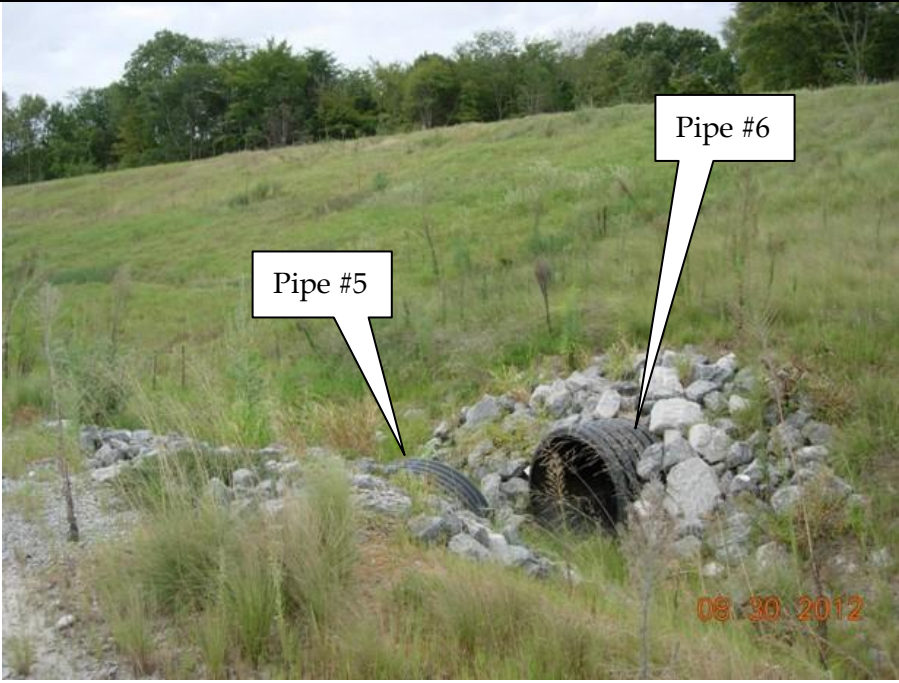
15	8-30-12		
Description <ul style="list-style-type: none"> • Phase 2 EC-23 • Pipes #5 and #6 associated with SW4. • The area immediately adjacent to Pipes #5 and #6 appeared to be sufficiently stabilized/vegetated.

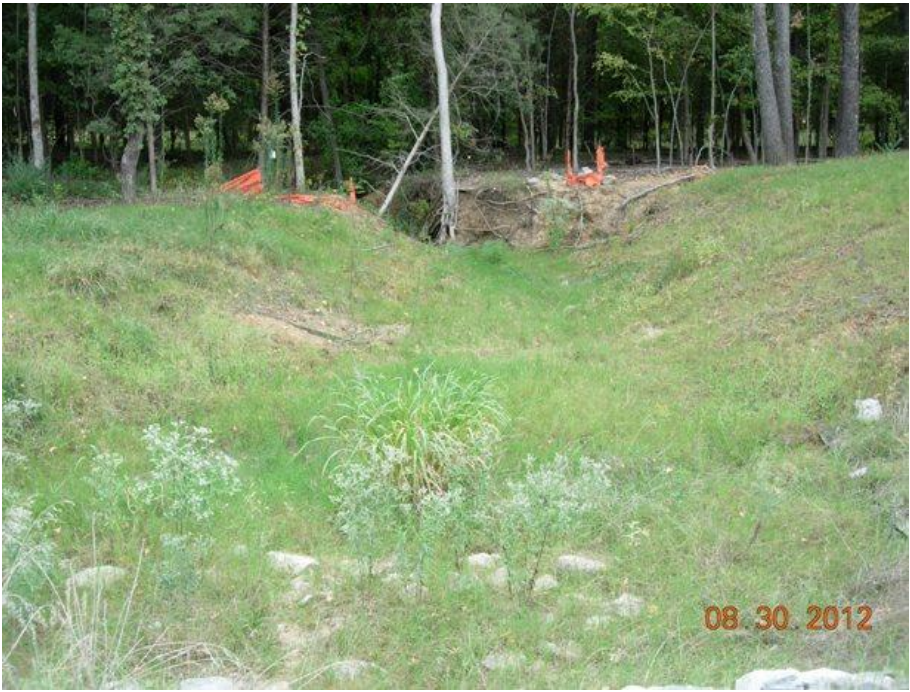
16	8-30-12	
Description <ul style="list-style-type: none"> • Phase 2 EC-23 • SW5 • The area surrounding SW5 appeared to be sufficiently stabilized/vegetated in some areas. However, the slope south of the outfall had sparse vegetative cover.

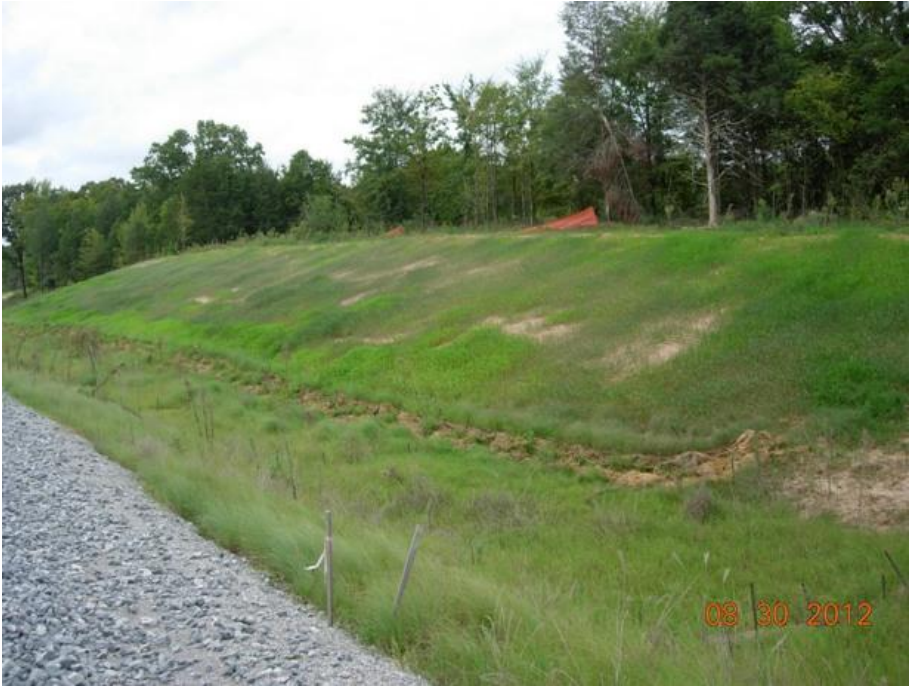
17	8-30-12		
Description <ul style="list-style-type: none"> • Phase 2 EC-23 • The slope/swale south of Pipe #7 was not sufficiently vegetated/stabilized in several areas. • Ms. Hagerty indicated that the area had been recently covered with ProMatrix. • Vegetation was emerging in areas, but remained sparse in other areas. • Insufficient stabilization/vegetation was previously documented during the inspections conducted August 23, 2011, and March 12, 2012.

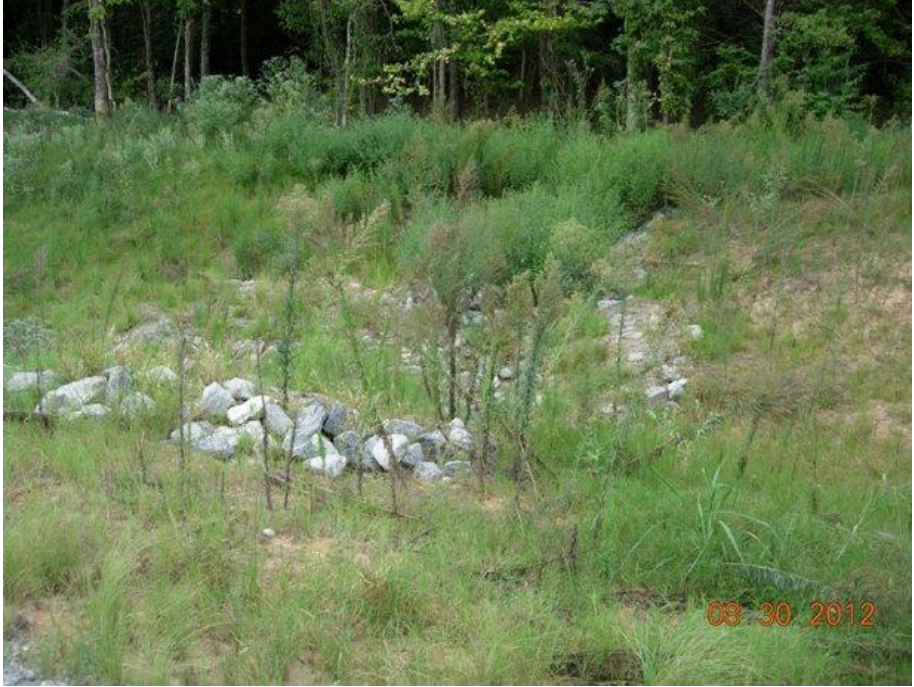
Operator:		Site Location:	Tracking No.:
Norfolk Southern Railway Company		Rossville, Fayette County	TN0081108
Photo No.	Date		
19	8-30-12		
Description <ul style="list-style-type: none"> • Phase 2 EC-24 • Pipe #8 • The slope/swale adjacent to the inlet of Pipe #8 had insufficient vegetative cover in many areas.

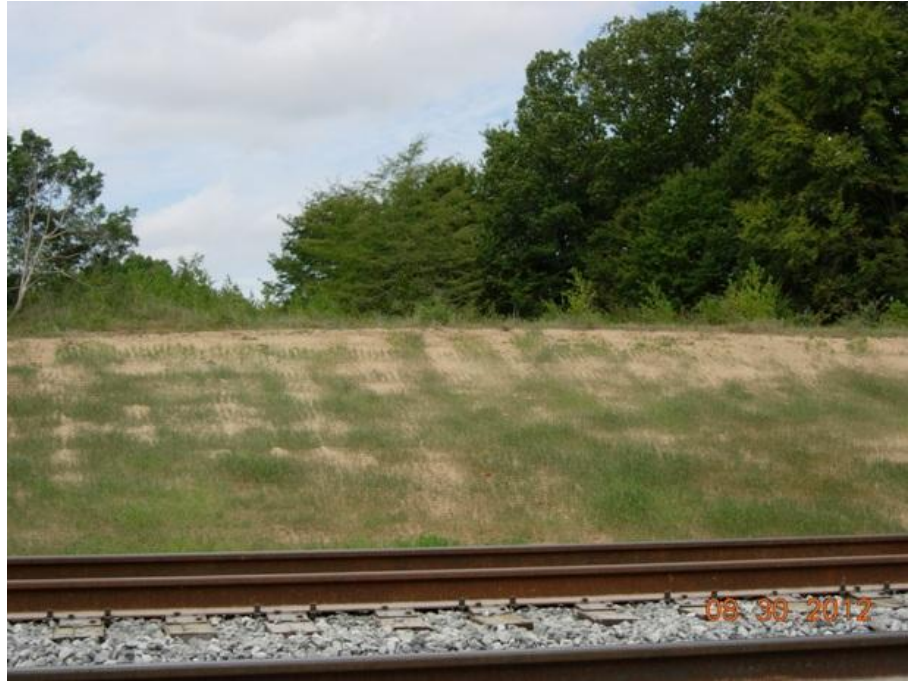
Photo No.	Date		
20	8-30-12		
Description <ul style="list-style-type: none"> • Phase 2 EC-24 • The slope south of the inlet of Pipe #8 was not sufficiently stabilized/vegetated.

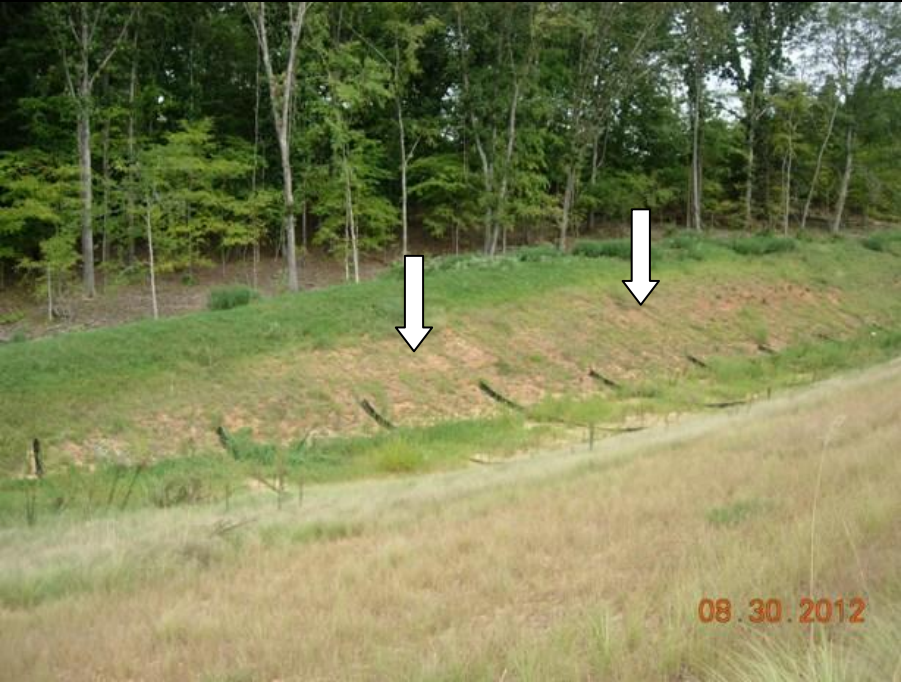
21	8-30-12		
Description <ul style="list-style-type: none"> • Phase 2 EC-24 • The swale which drains to SW27 is shown in this photo. • The vegetative cover was insufficient in many areas including, but not limited to the areas indicated by the arrows. • Insufficient stabilization/vegetation was previously documented during the inspections conducted August 23, 2011, and March 12, 2012. • No discharge was occurring at SW27 at the time of the inspection.

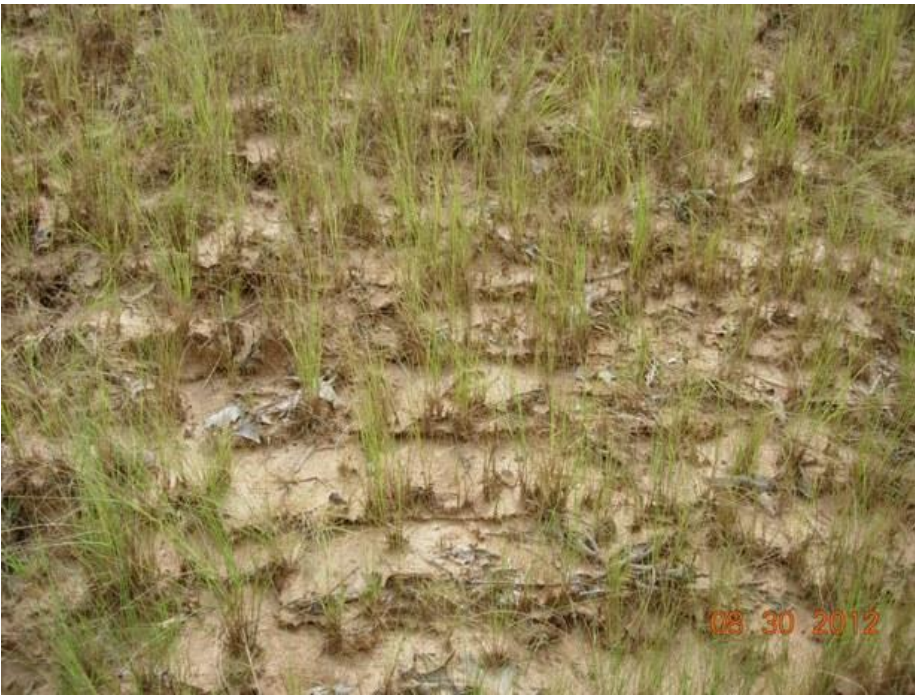
22	8-30-12		
Description <ul style="list-style-type: none"> • Phase 2 EC-24 • This photo shows an example of the slope up-gradient from SW27, SW28 and Stream 3. The slope was not sufficiently stabilized. • Although what appears to be Weeping Lovegrass was emerging, the slope was virtually unchanged from the previous August 23, 2011 and March 12, 2012, inspections.

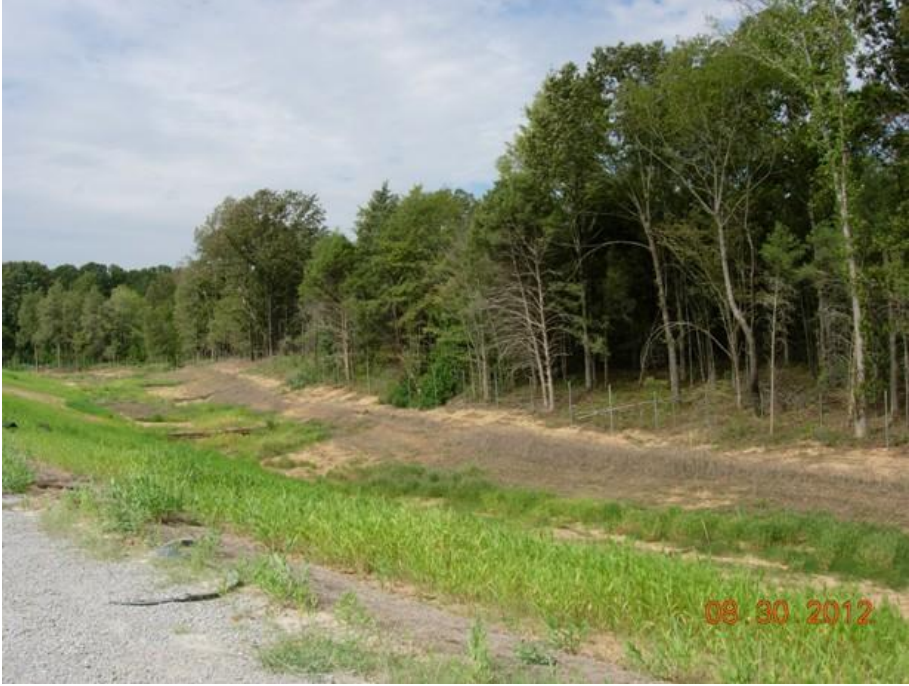
Operator: Norfolk Southern Railway Company		Site Location: Rossville, Fayette County	Tracking No.: TN0081108
Photo No. 27	Date 8-30-12	<div> <div> Description <ul style="list-style-type: none"> • Phase 2 EC-25 • Another portion of the slope/swale on the western side of the site, north of Sediment Basin 1, which discharges to SW28 is shown in this photo. • This photo is up-gradient (southwest) of photo 26. • The slopes were not sufficiently vegetated. • Although this area appeared to have more established vegetation than during the November 22, 2011, and March 12, 2012, inspections, the area remains insufficiently stabilized/vegetated. • The fence installation has also caused recent soil disturbance. </div> <div>

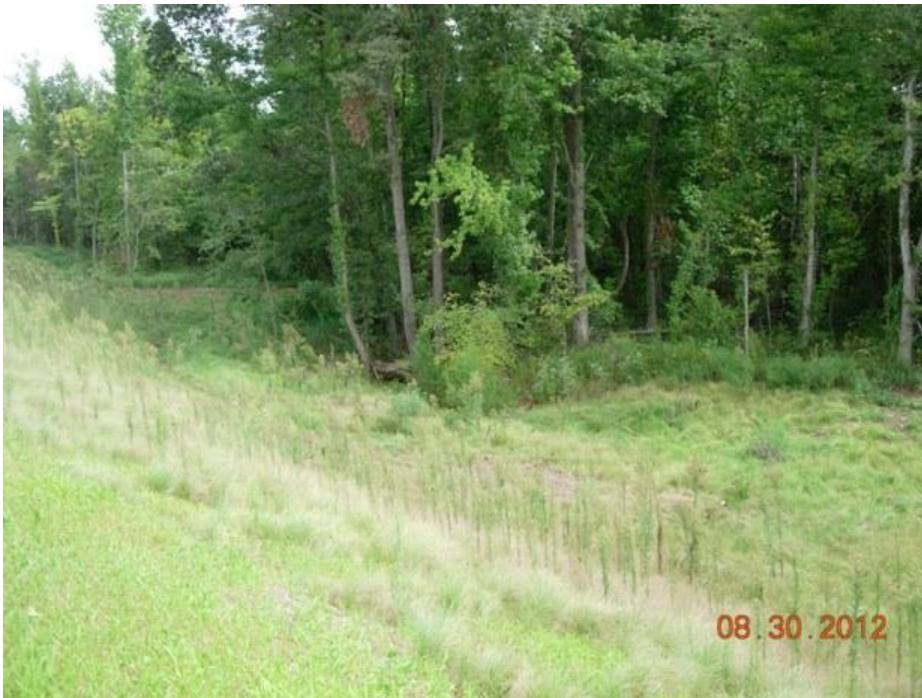
Description <ul style="list-style-type: none">• Phase 2 EC-24• SW7• Most of the area surrounding SW7 appeared sufficiently vegetated; however, Ms. Hagerty stated that the slope up-gradient of SW7 was recently re-graded and sprayed with Flexterra.• The dominant grass emerging appeared to be rye; however, some Bermuda was observed.• Neither grass was fully established and was therefore unable to provide complete and sufficient cover (see photo 29).

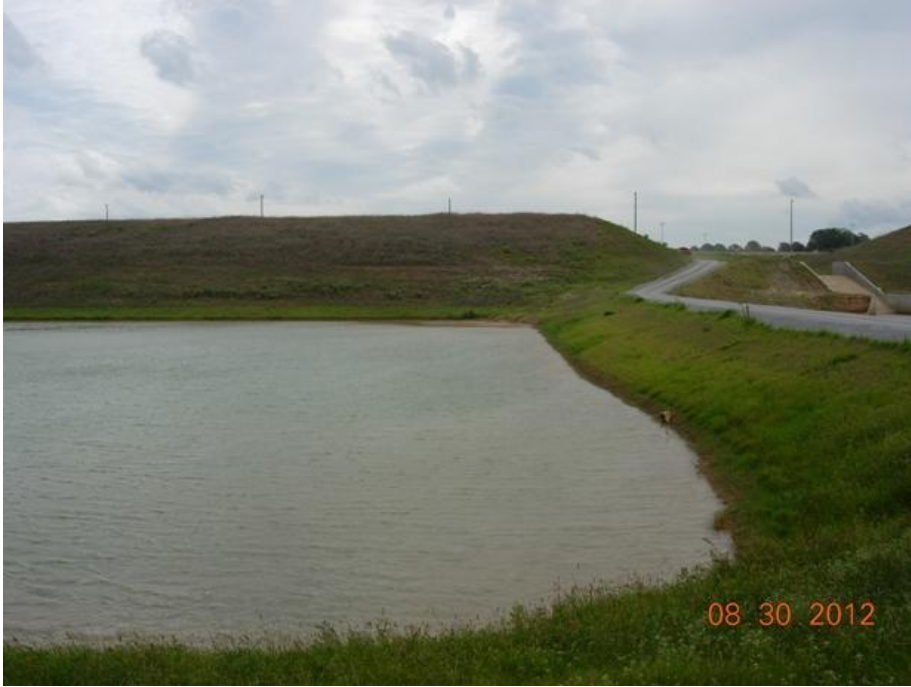
- Phase 1A EC-19 and 2 EC-29
- Sediment Basin 2
- Looking east at the southern portion of the basin.
- The vegetative cover on the banks of the basin appeared sufficient in most areas; however, some sparse areas were observed.
- The water in the basin had been chemically treated and was being dewatered via a pump to SW30.

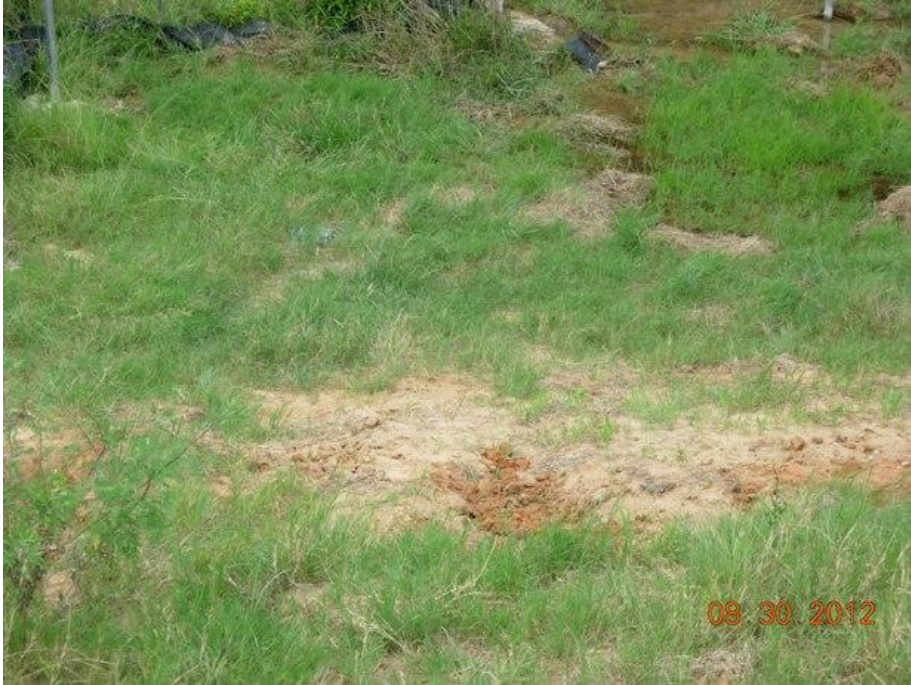
39	8-30-12		
Description <ul style="list-style-type: none"> Phase 2 EC-29 This area north of SW31 was not sufficiently vegetated.

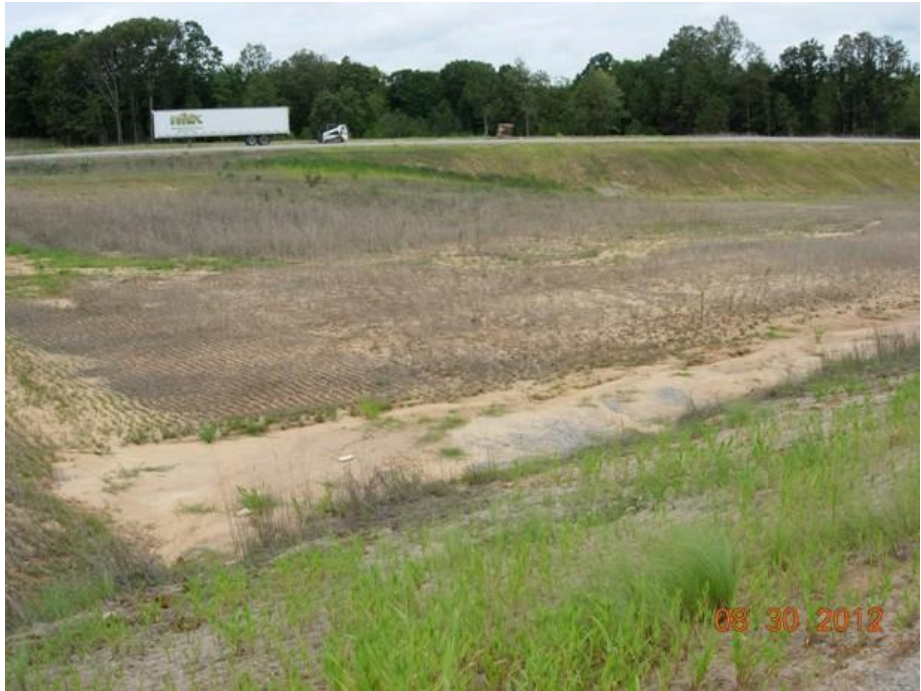
45	8-30-12		
Description <ul style="list-style-type: none"> • Phase 2 EC-25 • The area associated with the outlet end of Pipe #13 and the inlet end of Pipe #12 is shown in this photo. • Pipe #12 discharges into Sediment Basin 1. • The area was not sufficiently vegetated. • Ms. Hagerty stated that the area was sprayed with Flexterra, but that it will be sprayed again with ProMatix.

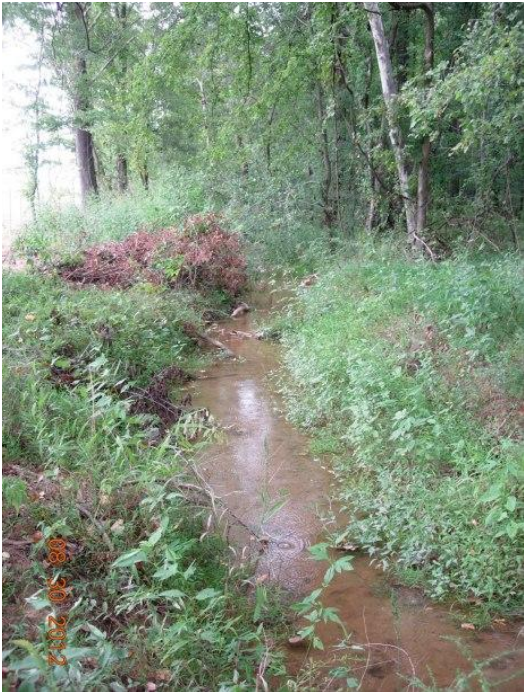
Photo No.	Date		
54	8-30-12		
Description <ul style="list-style-type: none"> • Stream 5 downstream of SW9 is shown in this photo. • The water in the stream appeared to be flowing in response to the discharge originating from the northern draining eastern drainage ditch/Sediment Basin 8.

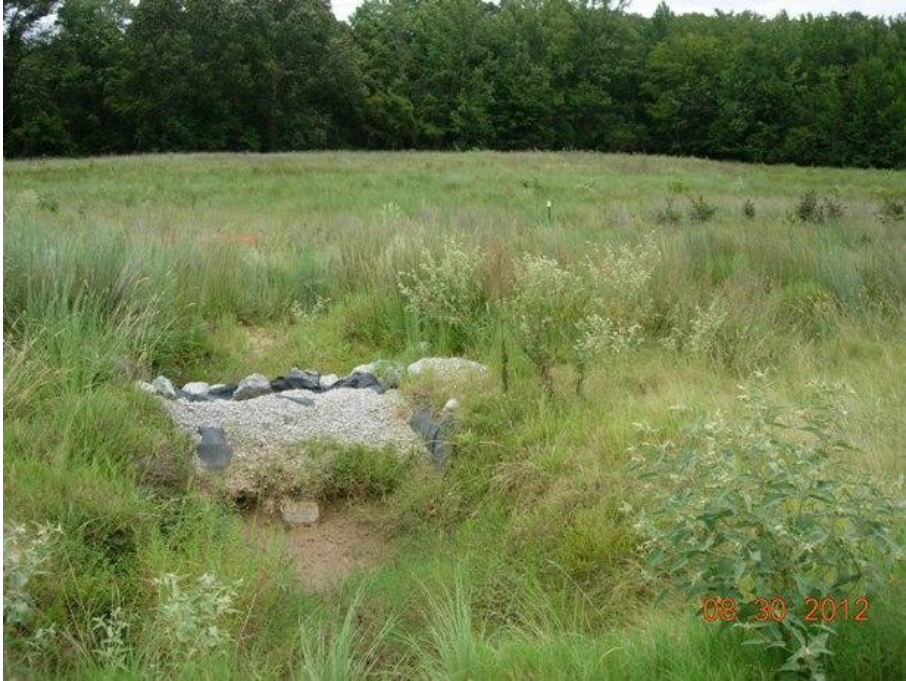
57	8-30-12		
Description <ul style="list-style-type: none"> Phase 1A EC-20 SW34 (outlet end of Pipe #41) Ms. Hagerty stated that the drainage swale down-gradient from the headwall was not at final grade and that the enhanced rock check dam would be removed. The area surrounding SW34 appeared well vegetated/stabilized.

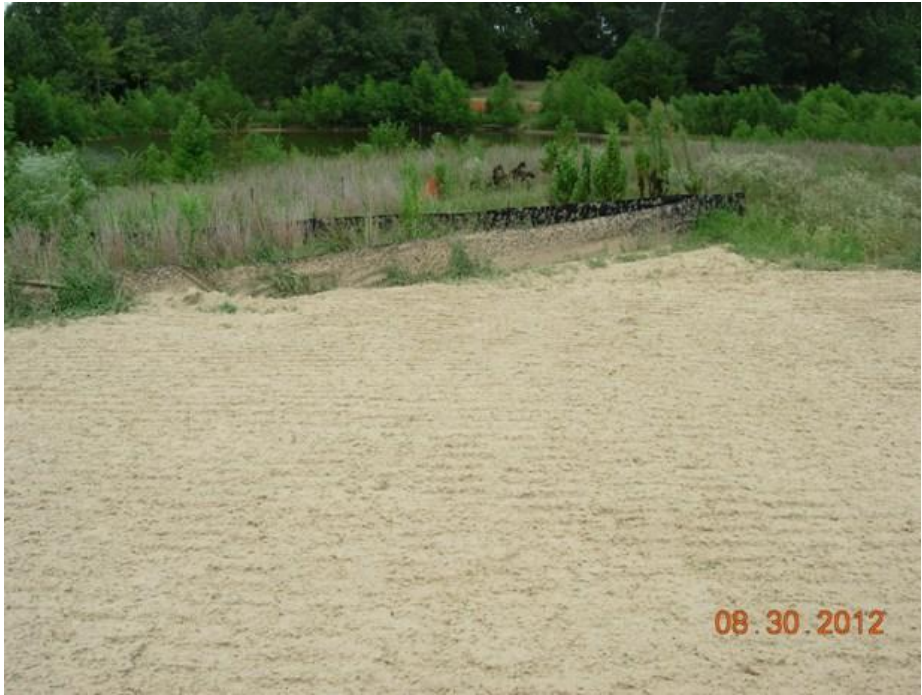
59	8-30-12		
Description <ul style="list-style-type: none"> • Phase 2 EC-30 • SW42 • Ms. Hagerty stated that the area surrounding SW42 was sprayed with Flexterra earlier in the week. • No vegetative growth had emerged yet. • The water in the pond north of SW42 appeared clear.

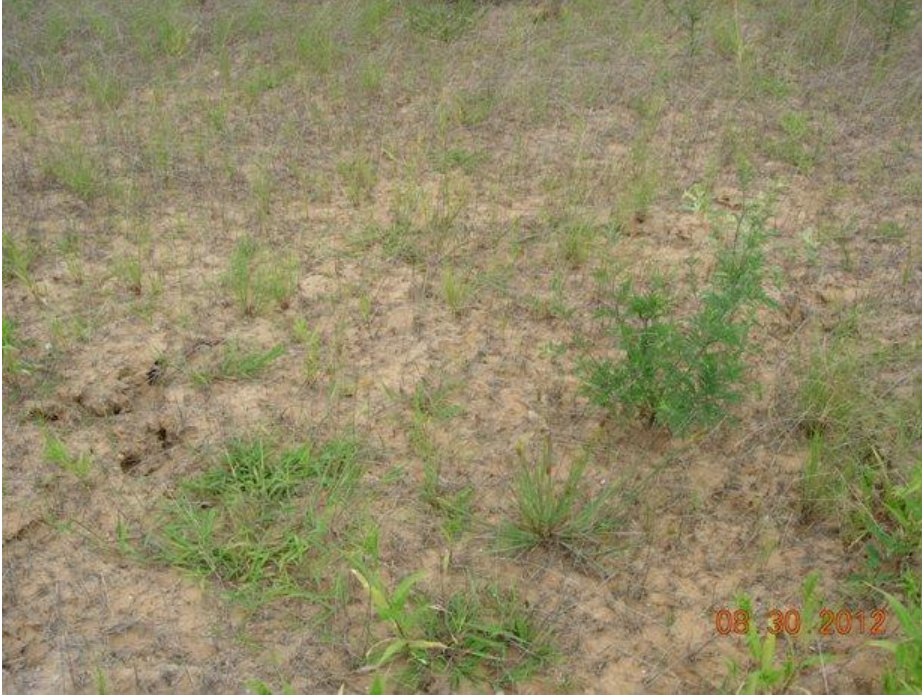
61	8-30-12		
Description <ul style="list-style-type: none"> • Phase 2 EC-30 • This photo is of the slope between SW38 and Pipe #31. • The vegetative cover was not sufficient. • Much of the vegetation appeared dead or dormant and did not appear permanent or perennial.

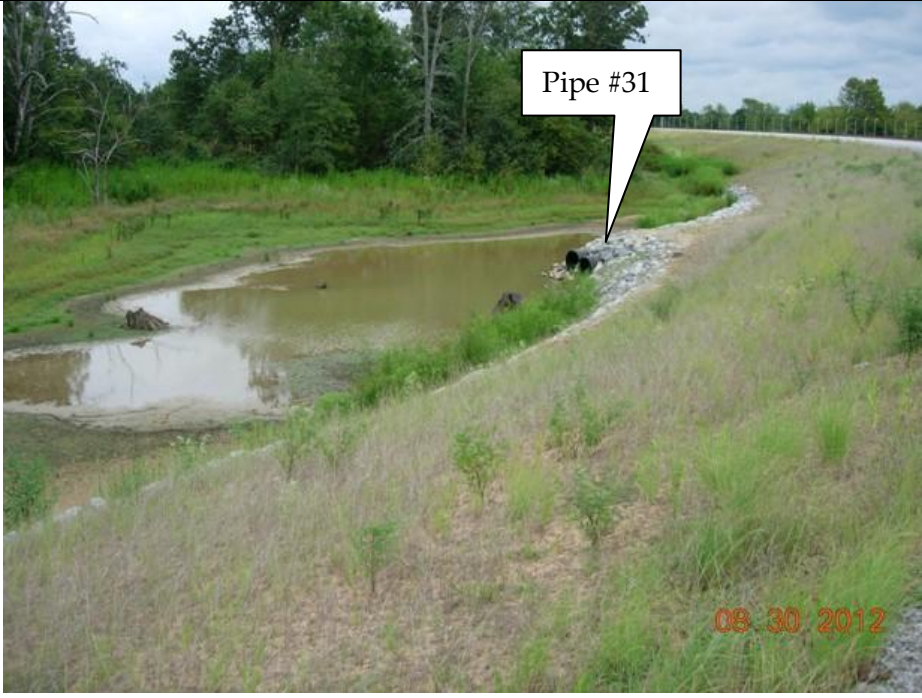
62	8-30-12		
Description <ul style="list-style-type: none"> • Phase 2 EC-30 • Pipe #31 is shown in this photo. • The slope between SW38 and Pipe #31 is also shown in this photo. • The vegetative cover was not sufficient. • Much of the vegetation appeared dead or dormant and did not appear permanent or perennial.

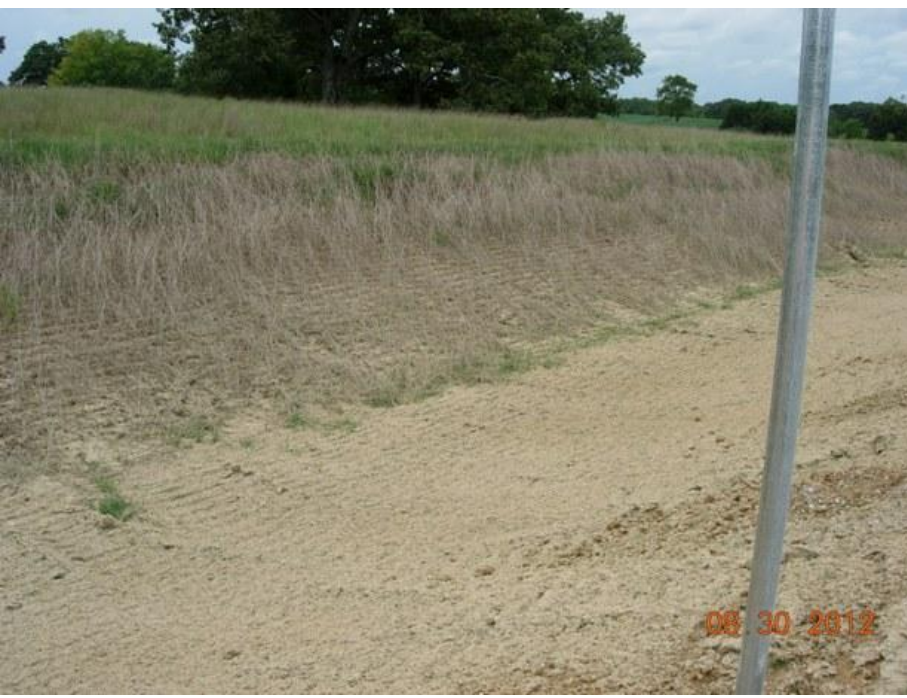
Photo No.	Date		
68	8-30-12		
Description <ul style="list-style-type: none"> • Phase 2 EC-27 • This photo was taken near Station 180+00 on the Loop Track. This area discharges to SW17. • Ms. Hagerty explained that this area was re-graded and covered with Flexterra approximately one month prior to this inspection. • No vegetative growth was observed yet.

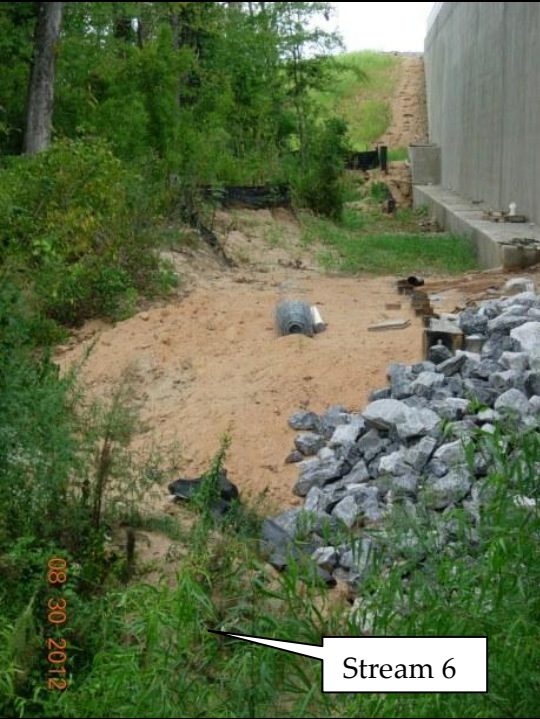
Operator:		Site Location:	Tracking No.:
Norfolk Southern Railway Company		Rossville, Fayette County	TN0081108
Photo No.	Date		
75	8-30-12		
Description <ul style="list-style-type: none"> • Phase 2 EC-27 • The northwestern corner of the Loop Track bridge adjacent to Stream 6 is shown in this photo. • No erosion prevention or sediment controls were installed on the bank of Stream 6.

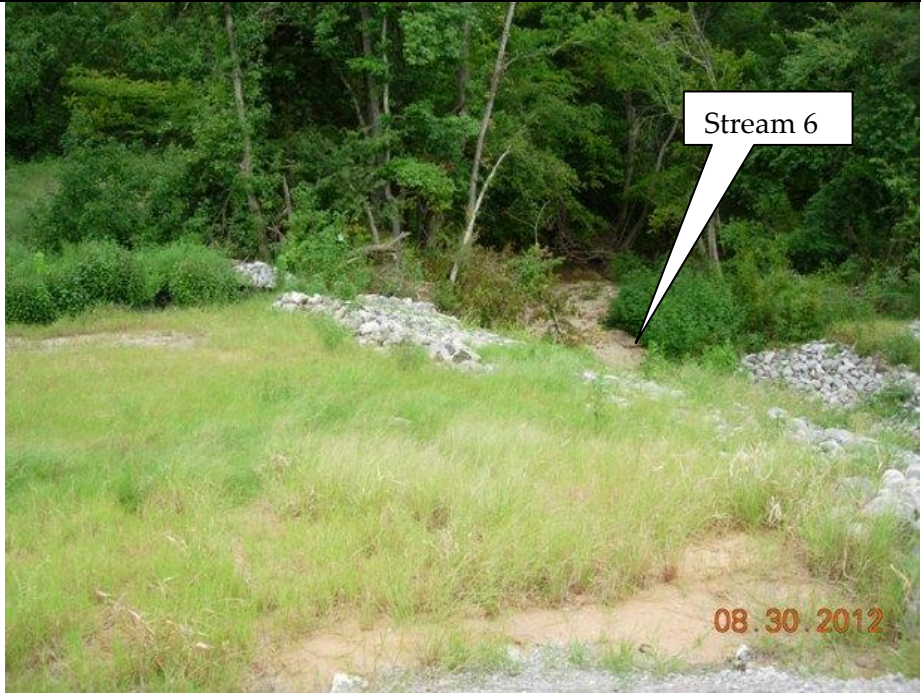
79	8-30-12		
Description <ul style="list-style-type: none"> • Phase 2 EC-27 • SW16 • Weeping Lovegrass was establishing, but was sparse in areas.

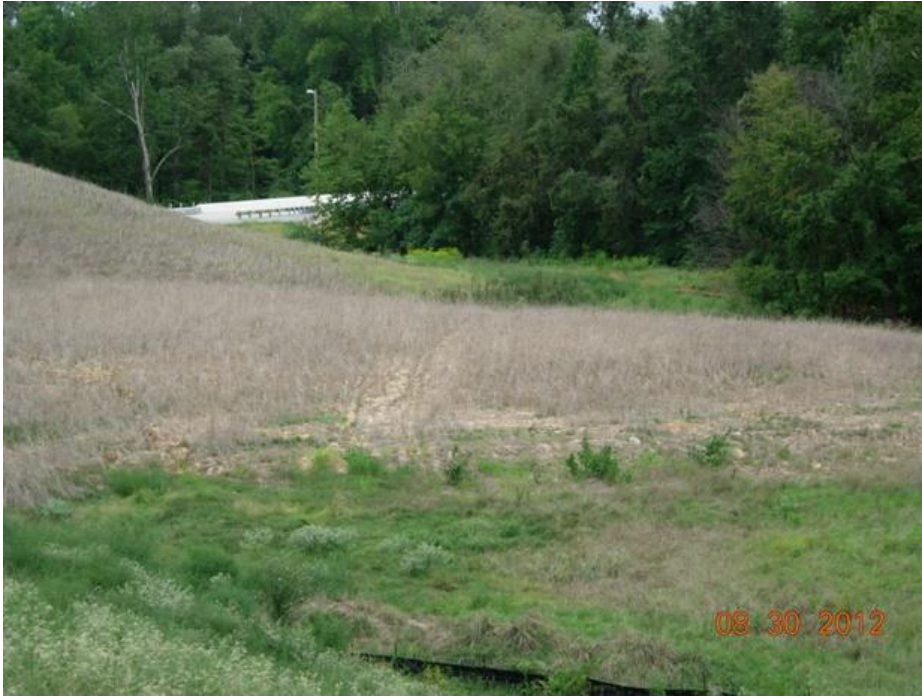
Operator:		Site Location:	Tracking No.:
Norfolk Southern Railway Company		Rossville, Fayette County	TN0081108
Photo No.	Date		
89	8-30-12		
Description <ul style="list-style-type: none"> • Phase 2 EC-26 and EC-29 • The slope east of the unaltered portion of Stream 4 and SW37 is shown in this photo. • Although the area appeared to have more established vegetation than during the March 12, 2012, inspection, the vegetative cover appeared dead or dormant, did not appear permanent or perennial and was not sufficient.

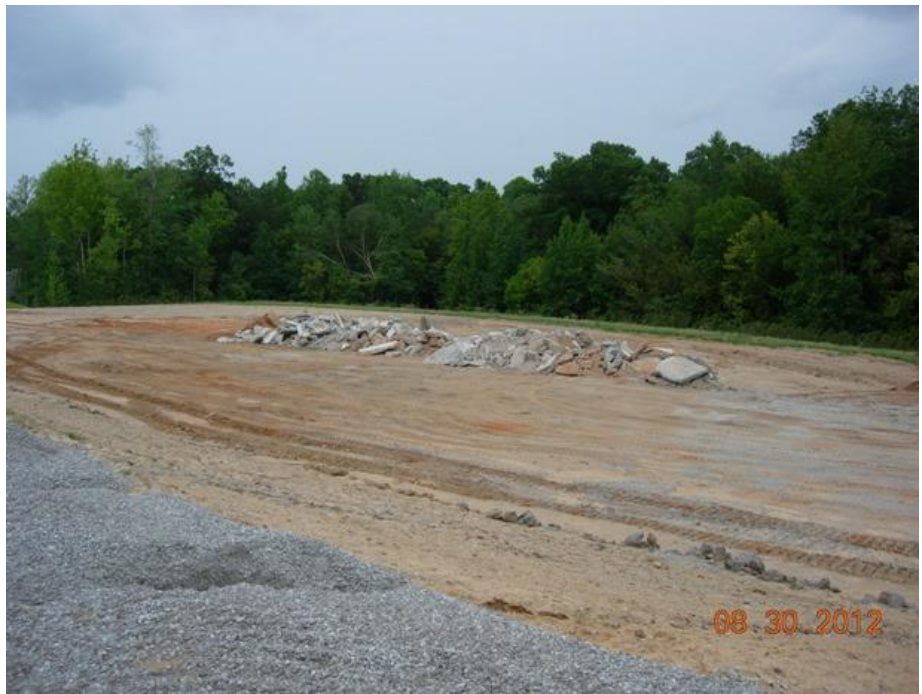
Photo No.	Date		
90	8-30-12		
Description <ul style="list-style-type: none"> • Phase 2 EC-27 • Former location of Sediment Basin 5 • Ms. Hagerty indicated that the area was being used to place fill material.

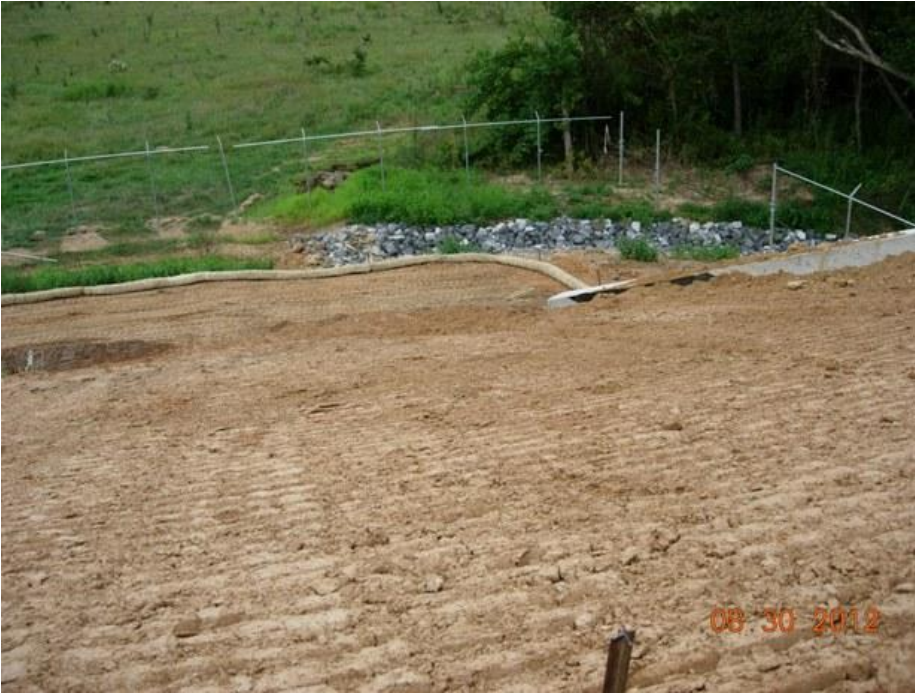
92	8-30-12		
Description <ul style="list-style-type: none"> • Phase 2 EC-27 • The slope adjacent to the northeast corner of the Loop Track bridge over Stream 6 is shown in this photo. • The slope was not stabilized. • One straw wattle at the toe of the slope would not be sufficient during a rain event. • The up-gradient portion of the southern draining eastern drainage ditch, which conveys drainage to SW12, was not sufficiently stabilized/vegetated –(see photos 93-96).

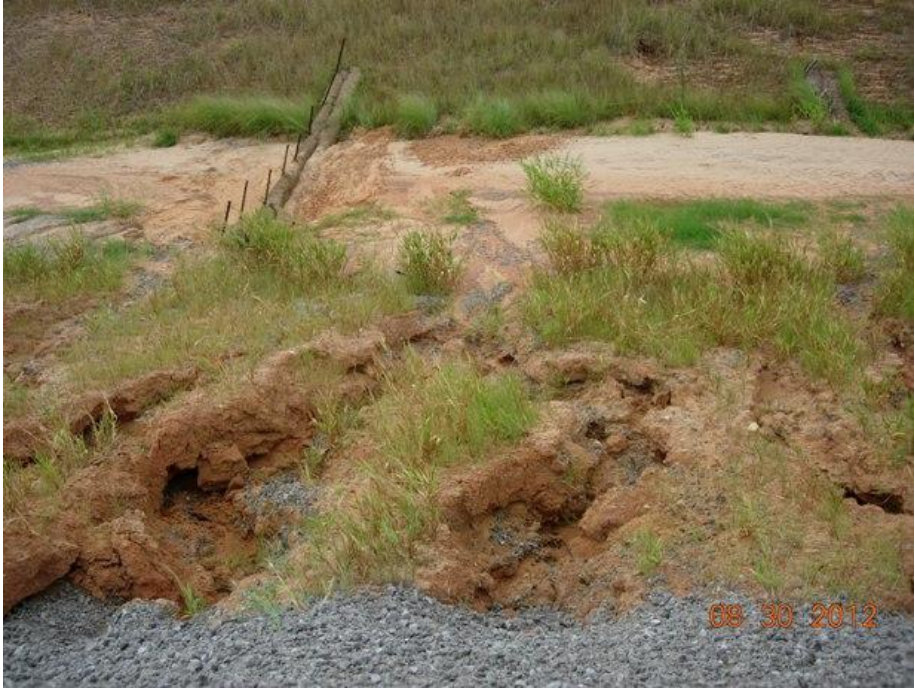
Operator:		Site Location:	Tracking No.:
Norfolk Southern Railway Company		Rossville, Fayette County	TN0081108
Photo No.	Date		
99	8-30-12		
Description <ul style="list-style-type: none"> • Phase 2 EC-27 • This photo is another example of the insufficient vegetation/stabilization on the northern draining eastern drainage ditch. • Although the area appeared to have more established vegetation than during the August 23, 2011, and March 12, 2012, inspection, the vegetative cover remains insufficient. • Drainage from this area flows into Sediment Basin 8, which was discharging at the time of the inspection. • Rills and gullies were observed. • Rills and gullies were also observed during the August 23, 2011, and March 12, 2012, inspections. • Sediment accumulation in the bottom of the swale is an indication of sediment loss from the slopes.

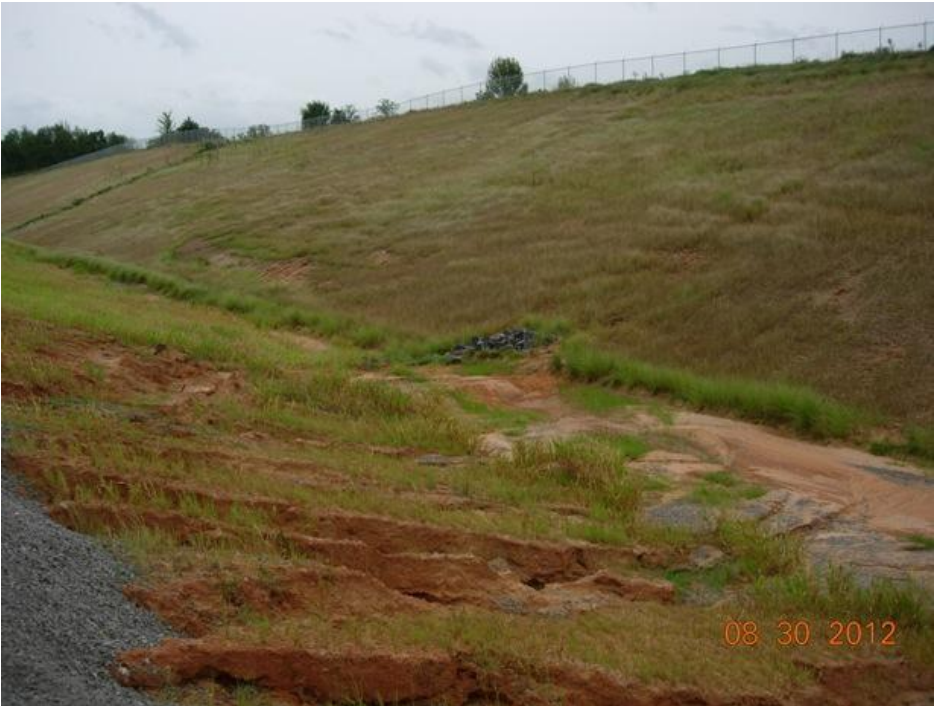
Operator:		Site Location:	Tracking No.:
Norfolk Southern Railway Company		Rossville, Fayette County	TN0081108
Photo No.	Date		
100	8-30-12		
Description <ul style="list-style-type: none"> • Phase 2 EC-27 • This photo is another example of the insufficient vegetation/stabilization on the northern draining eastern drainage ditch. • Although the area appeared to have more established vegetation than during the August 23, 2011, and March 12, 2012, inspection, the vegetative cover remains insufficient. • Drainage from this area flows into Sediment Basin 8, which was discharging at the time of the inspection. • Rills and gullies were observed. • Rills and gullies were also observed during the August 23, 2011, and March 12, 2012, inspections. • Sediment accumulation in the bottom of the swale is an indication of sediment loss from the slopes.
